Cowal gold mine; Success in mining through saprolites - a case history

by Ron Crouse and Shane Wright

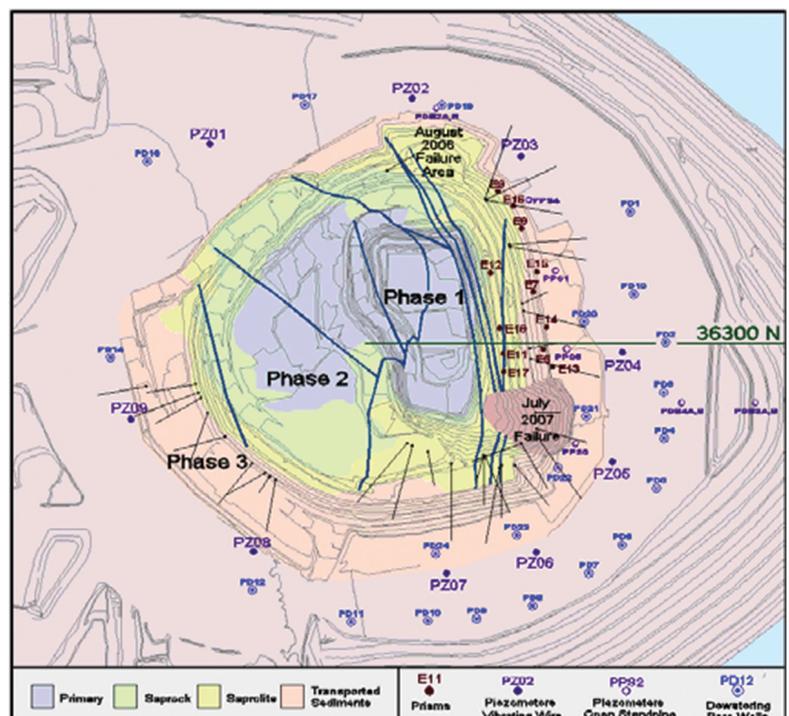
Figure 5

Pit prior to second east wall failure – mid December 2007.

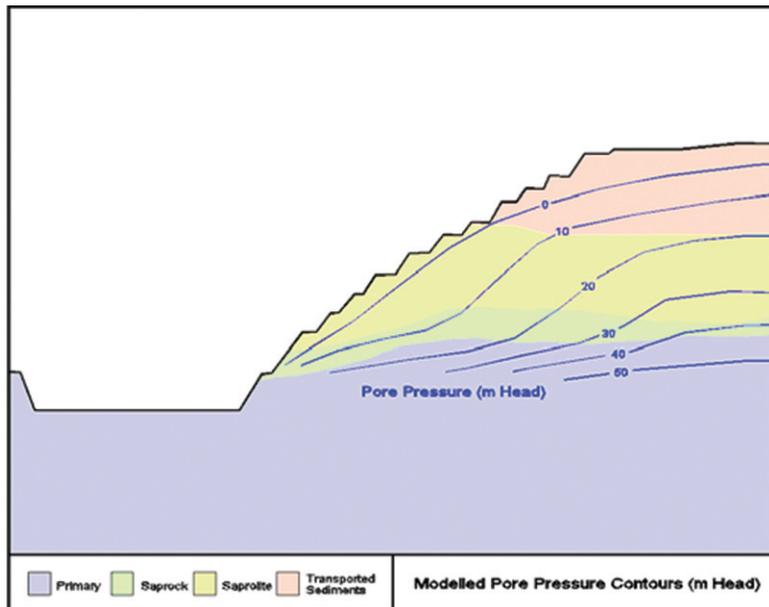
Cross section 36300N prior to second east wall failure.

Figure 6 exhibits an interpretation, based on the information available at the time, of the distribution of the pore pressure head within the east wall slope prior to the failure. A natural drainage of the saprock materials was captured with this interpretation but, overall, a high degree of ground water pressure was retained in the slope.

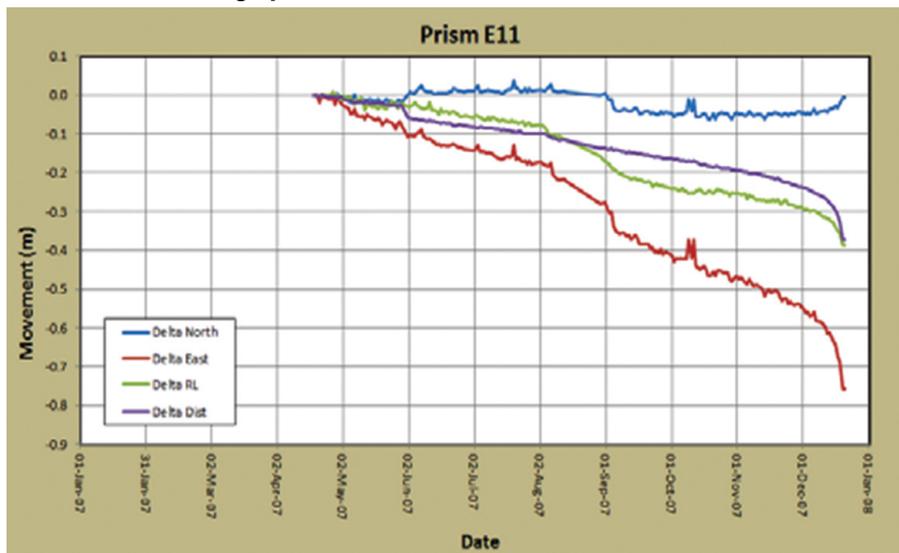
Figure 7

Prism E11 movement graph.

At the time, prism monitoring and movement analysis procedures prior to the failure had not been well defined. The prism coverage was inadequate, so the initial wall movement in the area of the second failure was not recorded. The graph for prism E11, which was located in the saprolite above the toe of the second failure, is illustrated in Fig. 7. It is clear from the graphs that

wall movement had already begun prior to installation of the prism.

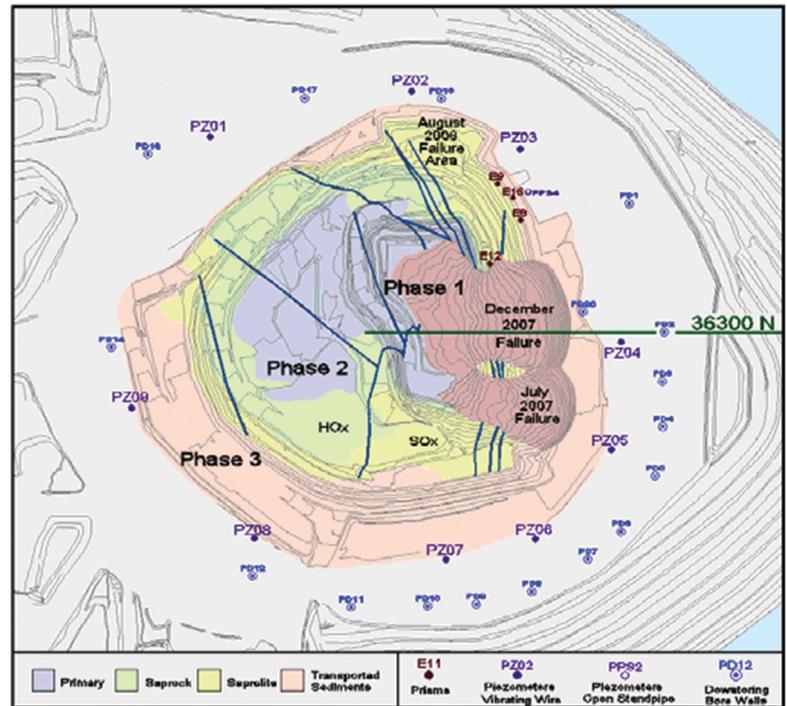
Figure 8

Pit prior to second east wall failure – mid December 2007.

The map in Fig. 8 shows the pit after the second failure. Note that almost the entire bottom of the Phase 1 pit had been filled with failure debris.

A photo taken two days after the failure confirmed that the failed mass contained a lot of internal water, as shown in Fig. 8.

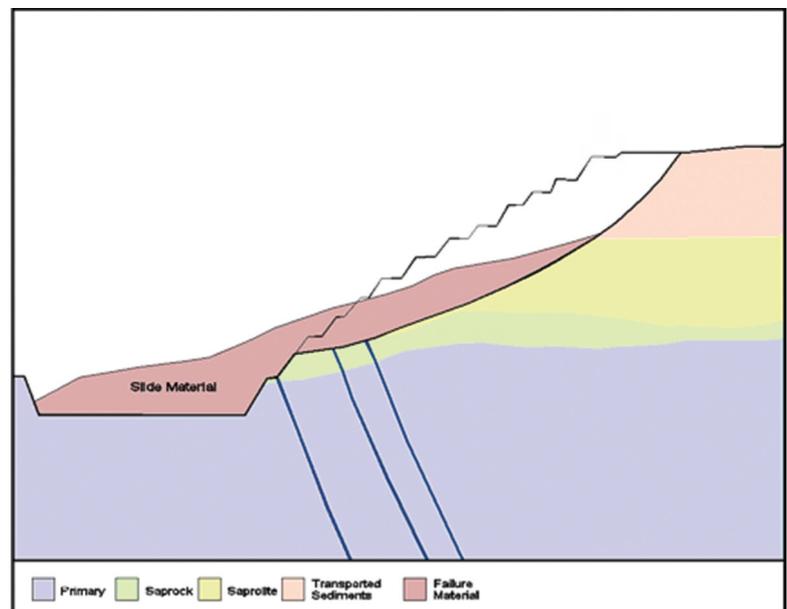
Figure 9

Cross section 36300N after second east wall failure.

The 2007 failures occurred in an area where the saprolites were very deep. The geometry of the failure surface followed the geometry of the base of the saprolite at the toe of the failure, which also happened to be at the location of the Cowal Fault Zone, represented by the three blue lines in Fig. 9.

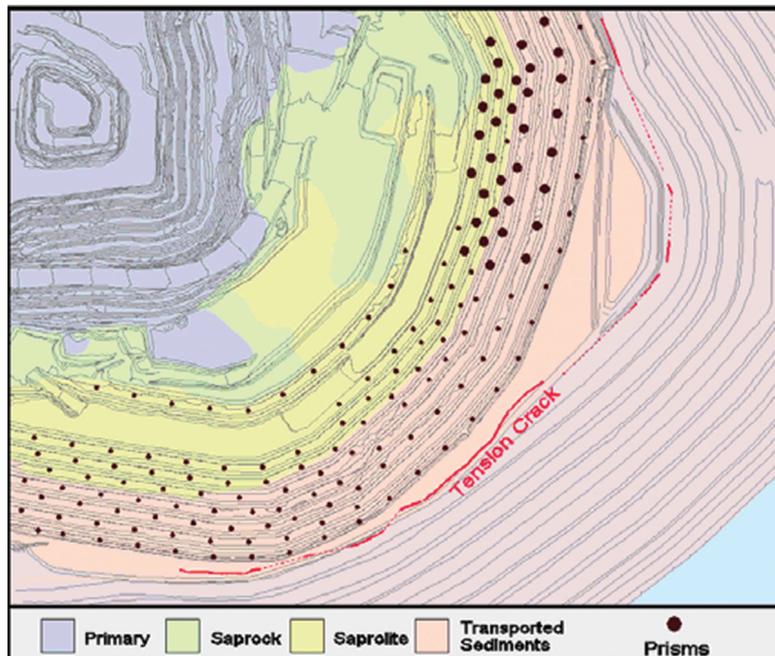
Figure 19

Tension crack along southeast pit crest – February 2013.

In February 2013, a tension crack was observed that paralleled the southeast pit crest. The crack was 2 cm wide at its widest, but nothing more than a hair line in many areas. Twelve pin sets were placed across it, which were measured weekly to determine if the crack was active. The pin sets showed no signs of active movement afterward.

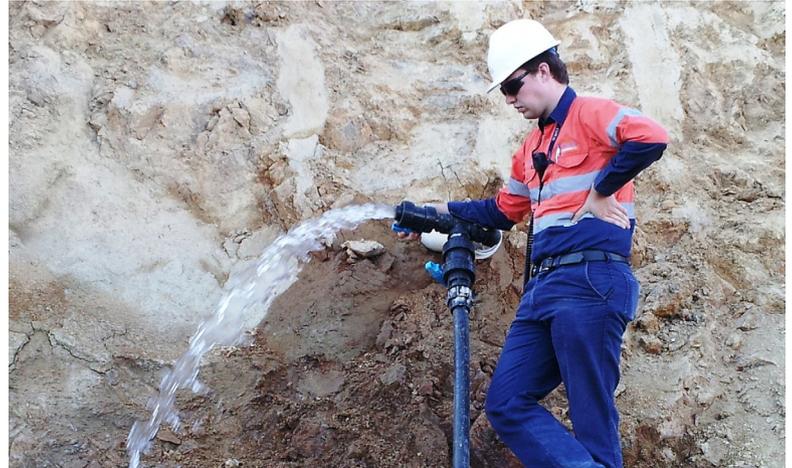
Figure 24

The Stage G horizontal drain program was modified based on the results of the previous Stage E drain drilling, with closer spacing and longer holes in areas that had produced the most water. As expected, large flows were observed in some drain holes in the base of the saprolite, as shown in Fig. 24.

Horizontal drain flow near base of saprolite - April 2013.

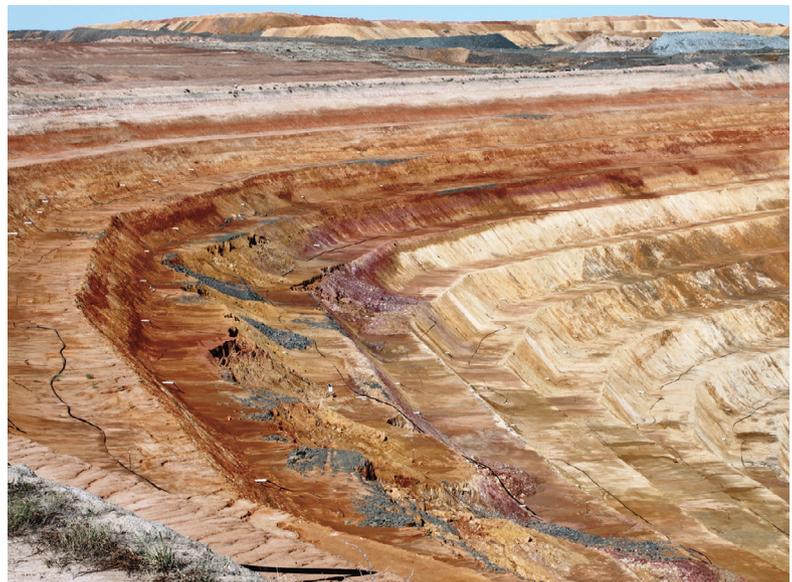
Figure 26

Despite continued creep, the southeast pit slope remained stable, except for several areas of multi-bench failures in the base of the transported sediments, which had retained high ground water pore pressures, and could not be effectively depressurized. Several of these failures are shown in Fig. 26.

The benches along the base of the transported sediments were wet, with small springs scattered along their length in the area with the failures. These failures, while ugly, were

nothing to be concerned about. The benches in the transported sediments above the failures remained intact.

Multi-bench failures at the base of the transported sediments.

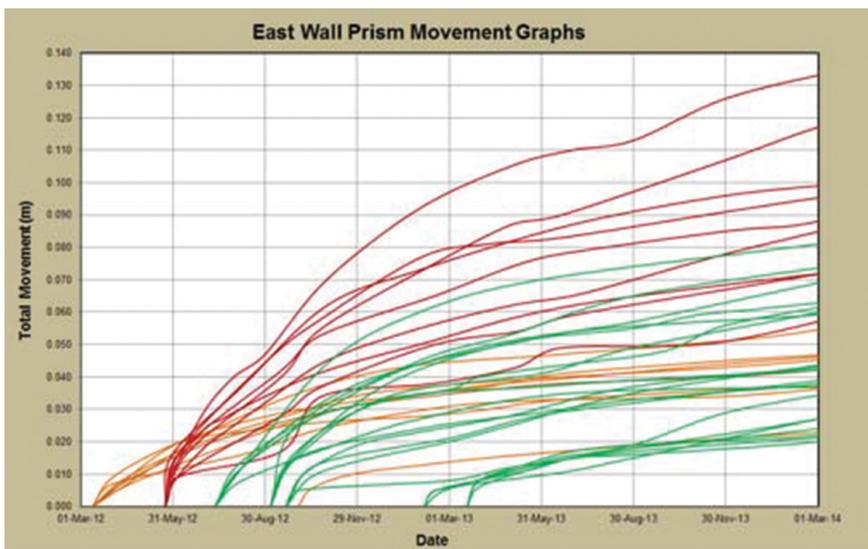
Figure 28

The steady decrease in rate of movement, along with the lack of movement across the tension crack located in February 2013, convinced the authors that the movement was the result of elastic rebound, and was not

indicative of eventual wall instability. Additional multi-bench failures are expected to form at the base of the transported sediments where prism movement of greater than 10 cm have been recorded.

Graph of east wall prism movement as of February 2014.
