# The blasting used to recover a dozer from a highwall

by **Tristan Worsley and Tyler Acron**

A dozer operator at a surface gold mine accidentally drove a D10 off the side of a highwall during a night shift. The blade of the dozer caught on the lip of a catch bench 18.3 m (60 ft) down, stopping its descent. The operator was able to exit the dozer and climb to safety.

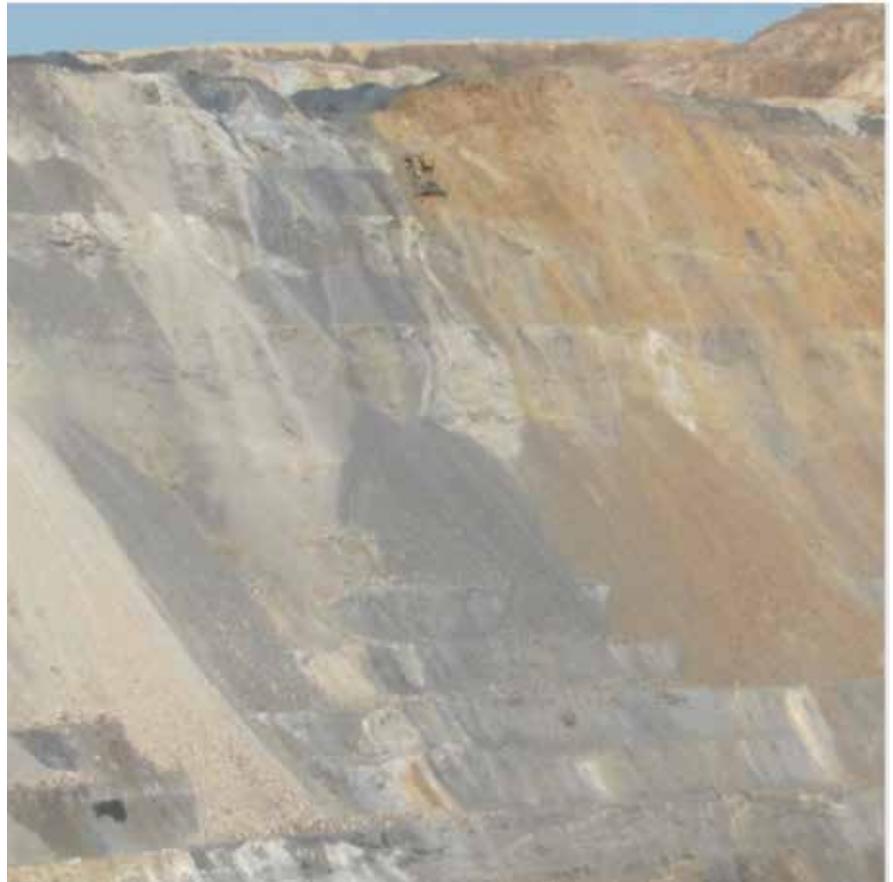
**Figure 1**

The highwall the dozer drove off was at a 65° angle but the dozer sat on the catch bench at a 40° angle. Figure 1 shows the dozer caught on the catch bench.

Day after the dozer drove off the highwall.

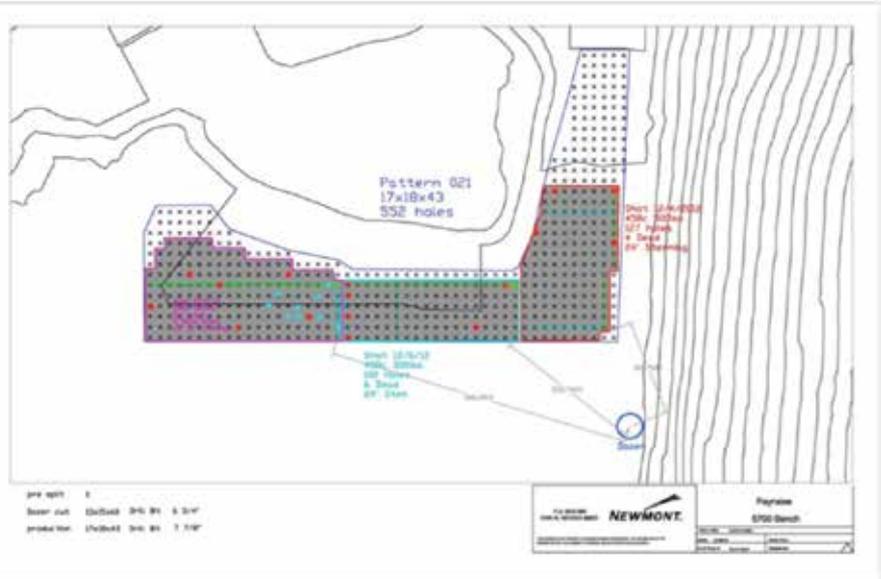
**Figure 2**

5,700 bench shot map.

The next two blasts were on the same bench as the first with the same design and timing. These blasts are outlined in pink (12-5-2013) and teal (12-6-2012) in Fig. 2. The second shot had 161 holes (8 dead) and was 161 m (529 ft)

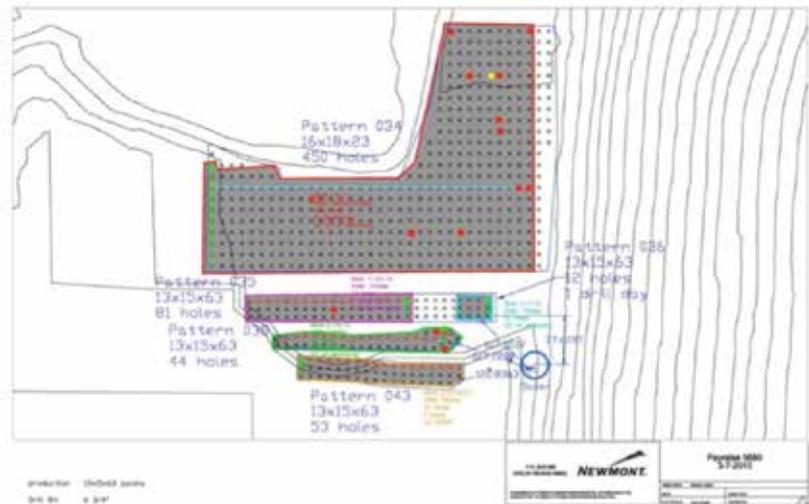
**Figure 3**

5,680 shot map.

around the dozer. This blast (1-2-13) is outlined in red in Fig. 3. This blast had less ground vibrations than the first shot that was similar in distance but this shot had less than half the lbs per delay. This blast had a lot of stemming ejection and was also quite violent as can be seen in Fig. 7. A lot of material was cascaded down the side of the highwall and there was some fly material that could have hit the dozer if it had been closer. There was a little bit of snow that fell down the high wall in front of the dozer but no actual material fell.

Shot number five next to the dozer was the first panel shot. There was a failure in the wall that split the pattern up into two shots. In Fig. 3, there is a gap in-between the pink and teal shots that was the area that failed. The pink pattern (1-24-13) was the panel shot first. The blast had 53, 19 m (63 ft) holes, and 318 kg (700 lbs) of explosives per hole. The closest hole to the dozer was 67 m (219 ft). This shot gave a PPV of 47.752 mm/s (1.880 in./s) at 13.4 Hz which was the lowest frequency. As shown in Fig. 8, the before and after dozer scans came back negative for significant movement. All of the scans looked similar except for one so only two scans are included here. In the scan, anything that is in blue is up to 0.3 m (1 ft) of material gain, gray is zero movement and orange is up to 0.3 m (1 ft) of lost material. The green color means it went out of the range of -0.3 m (-1 ft) to 0.3 m (1 ft). The scan shows that the material near the dozer was basically unaffected. The material that is right next to the free face shows a little bit of loss but it was right in front of the blast and was expected to see a little bit of movement. One thing to note from this scan is that the material next to where the blast was located was unaffected. This meant that it was a safe distance (43 m or 140 ft) from the highwall to put the blast once patterns were placed directly behind the dozer. This blast, shown in Fig. 9, had the least amount of fly material and only one stemming ejection that was from a hole plugged during stemming.

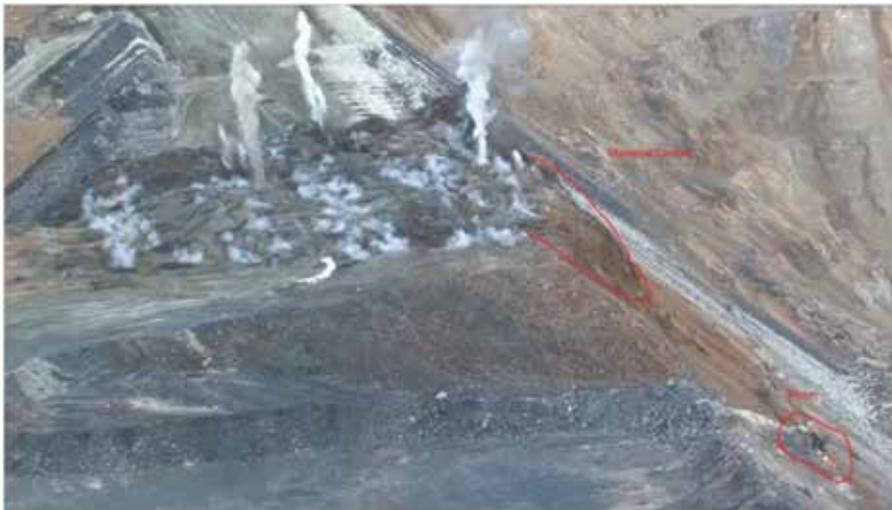
## Figure 4

The first blast went well. Laser profile scans were taken before and after the blast and showed minimal movement. Figure 4 shows a picture of the blast with the dozer in the lower right hand corner. The dozer was 50.6 m (166 ft) away from the blast. It was decided to bring

First dozer shot.

4-2012 blast bordered in red.

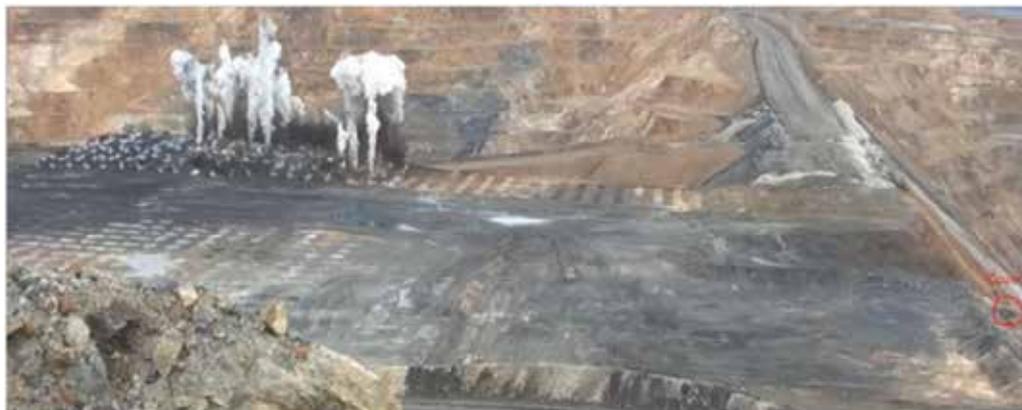
## Figure 5

away from the dozer. This shot had a peak particle velocity of 5.334 mm/s (0.210 in./s) at 9.3 Hz with the lowest frequency being 8.9 Hz at 4.572 mm/s (0.180 in./s). Little to no movement was reported from the scans for the material around the dozer and the dozer itself. In Fig. 5, the blast shows a little stemming ejection. This is very common when using detcord down the hole as an initiator. The stemming ejection caused quite a bit of fly material that was unwanted as blasting progressed closer to the dozer. The third shot had 102 holes (six dead) and was 77 m (251 ft) away from the dozer. This shot had a PPV of 34.544 mm/s (1.360 in./s) at 17.0 Hz with the lowest frequency being 10.2 Hz at 1.360 in./s (34.544 mm/s). The scans reported little to no movement of the dozer from before the blast.

Second dozer shot.

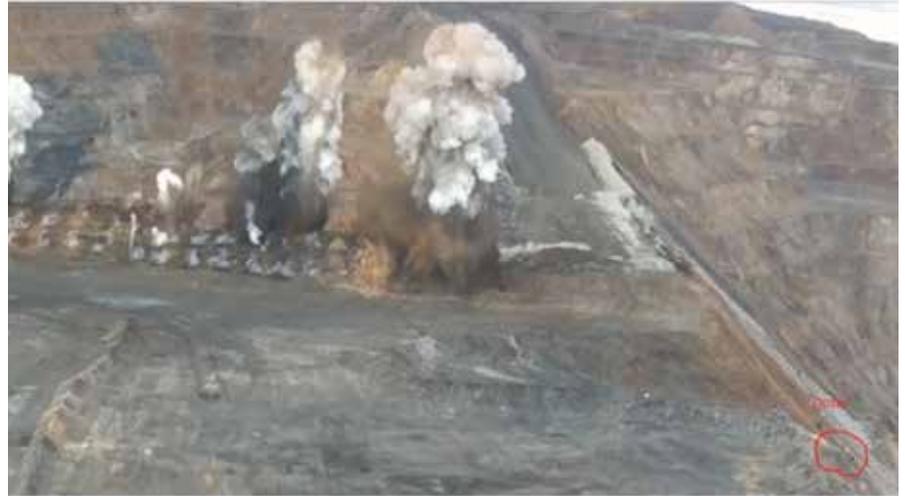
## Figure 6

In Fig. 6, the blast shows a little more violent stemming ejection.

Third dozer shot.

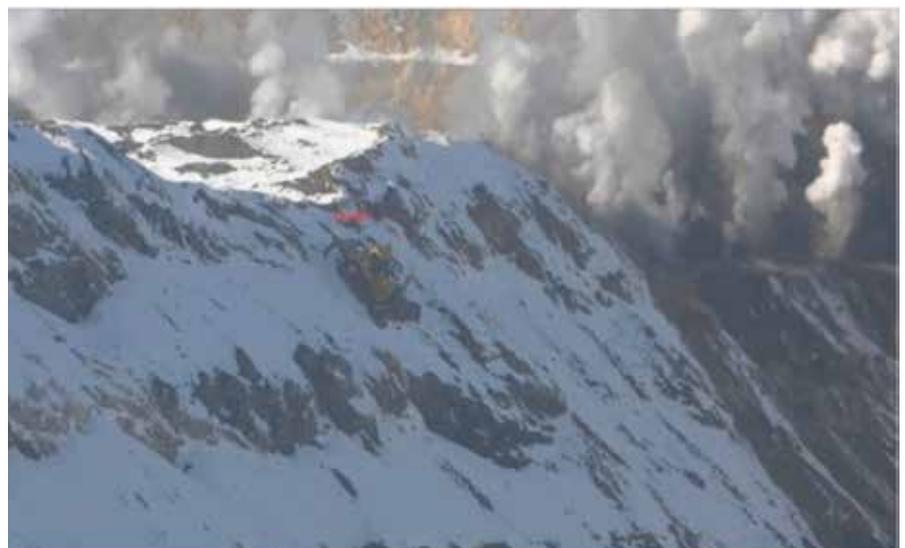
## Figure 7

Fourth dozer shot.

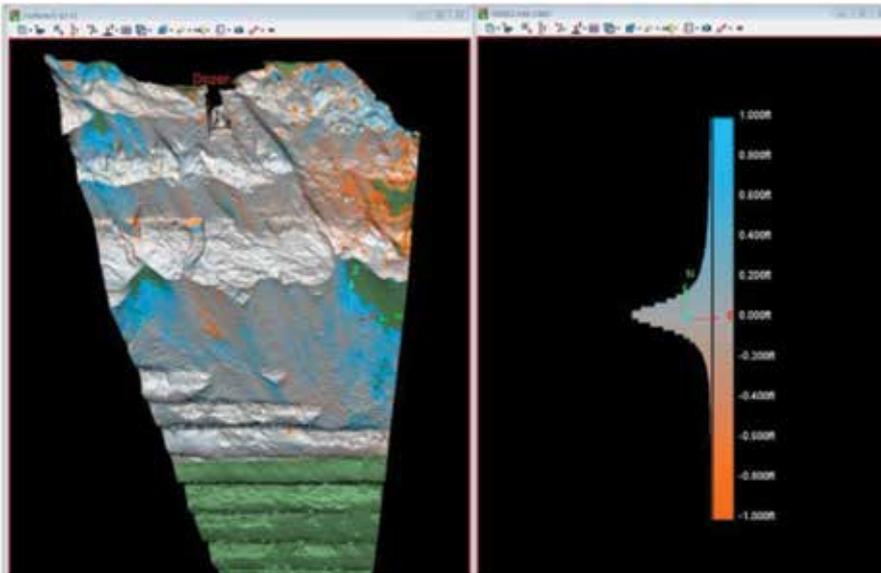
## Figure 8

Before and after scan of the first panel shot.

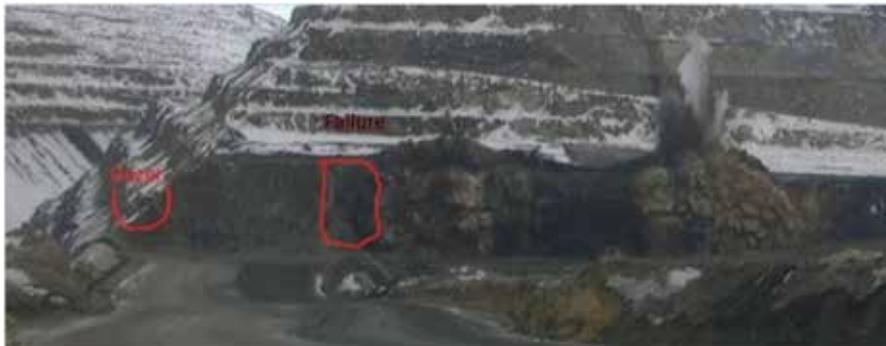
## Figure 9

Fifth dozer shot.

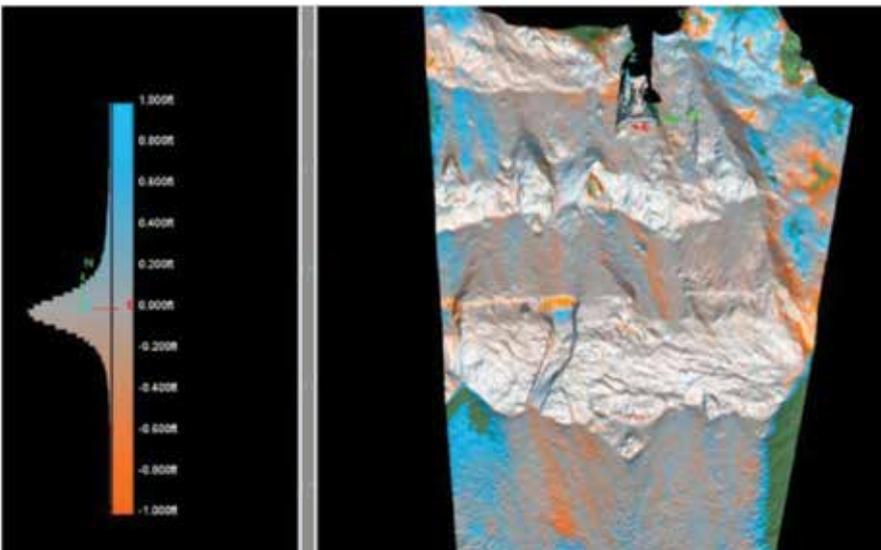
## Figure 10

six. This pattern was only 33 m (108 ft) away from the dozer and had more burden than designed due to the failure. This pattern also had some short holes in the middle of the pattern. This shot gave a PPV greater than 127 mm/s (5 in./s). Unfortunately, the seismograph was set to a max of 127 mm/s (5 in./s), so data was not received. The scan showed little to no movement on and around the dozer. This was a good sign that the dozer was pretty well set in the catch bench and, as long as the material in the catch bench didn't get casted, the dozer would be fine. One observation from this blast was that the material in between the dozer and the blast did show a little bit of movement, as seen in Fig. 10. It was then decided to pull the rest of the panels 15 m (50 ft) back. Figure 11

Dozer scan of the sixth shot.

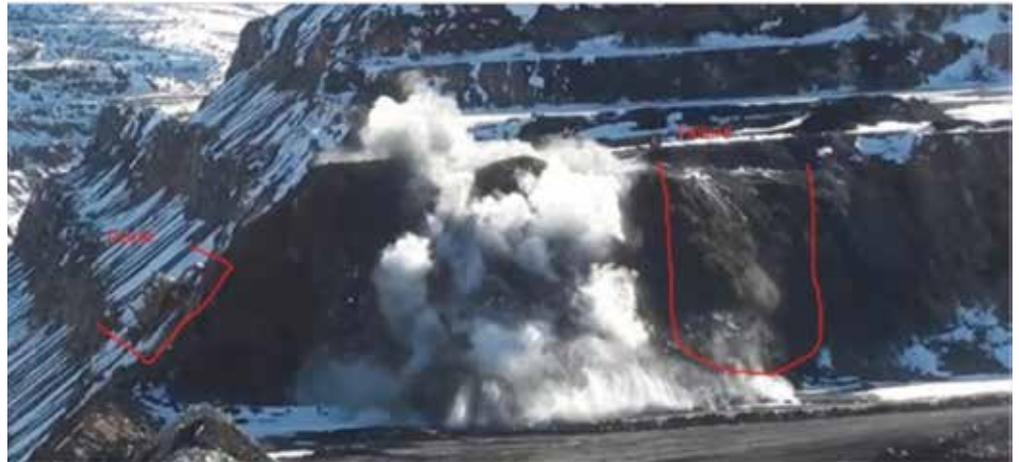
**Figure 11**

shows a photo of the shot that had no fly material and no stemming ejection.

Sixth dozer shot.

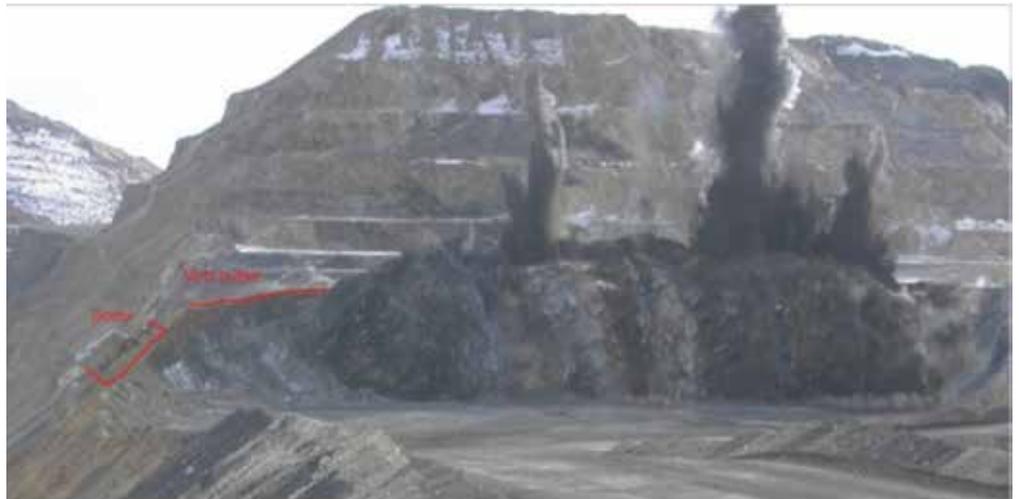
**Figure 12**

Shots seven (2-14-13) and eight (2-27-13) were similar in design to the first panel shot and can be seen in Fig. 3 in green and yellow, respectively. Shot seven was 39 m (128 ft) away from the dozer and occurred while the blasting engineers were unavailable. The seismograph monitors were improperly set up and a valid reading was not obtained. The video was also missed, but the before and after dozer scans showed little to no movement of the dozer and the surrounding material. This shot was slightly north of being behind the dozer. Shot eight was the last dozer shoot needed for equipment space to retrieve the dozer and was slightly south of being behind the dozer. This shot had 53 19-m (63-ft) holes (0 dead), and 318 kg (700 lbs) of explosives. This shot gave a PPV of 223.52 mm/s (8.80 in./s) at 28.4 Hz with the lowest frequency of 4.7 Hz at 152.4 mm/s (6.00 in./s). The scans showed little to no movement of the dozer or the material around it. Figure 12 shows a photograph of the eighth dozer blast. This shot had some stemming ejection that was caused by using drill cuttings and hole plugging.

Eighth dozer shot.

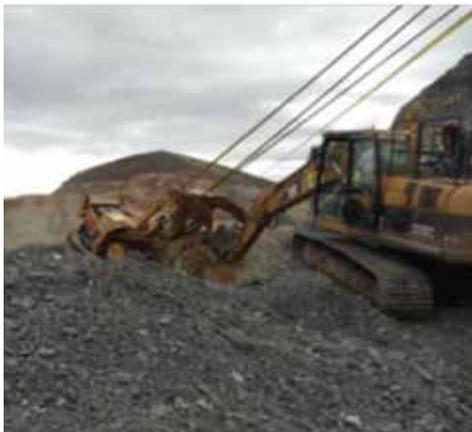
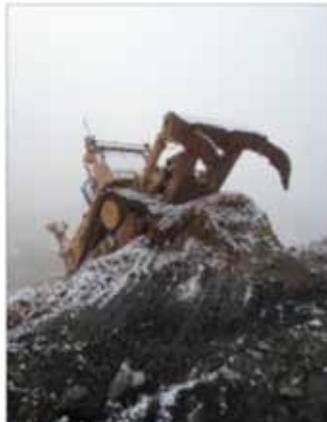
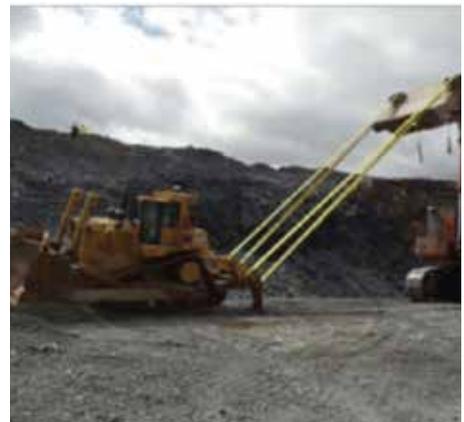
**Figure 13**

After the eighth shot, the bench was down to the dozer blade elevation and there was enough room for equipment to operate. The 15-m (50-ft) buffer zone ended up being easy to dig due to the shock wave from the blast creating microfractures in the rock. This was expected but not as well as it did. Figure 13 shows the dozer after final excavation of the buffer zone. The removal of the dozer was done by strapping onto the tool bar with the shovel and digging the material out from under it with a backhoe and then dragging it to more stable ground. The dozer had no blast damage and all of the glass was intact. Once the dozer was inspected and the fluids changed, it was out in the pit again working.

Dozer after final excavation.
