Cowal gold mine; Success in mining through saprolites - a case history

by Ron Crouse and Shane Wright

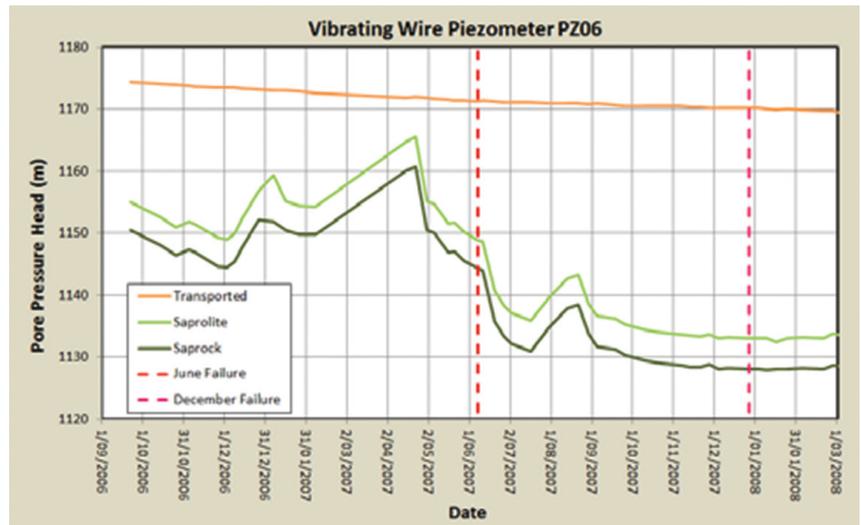
Figure 4

Piezometer PZ06 pore pressure head.

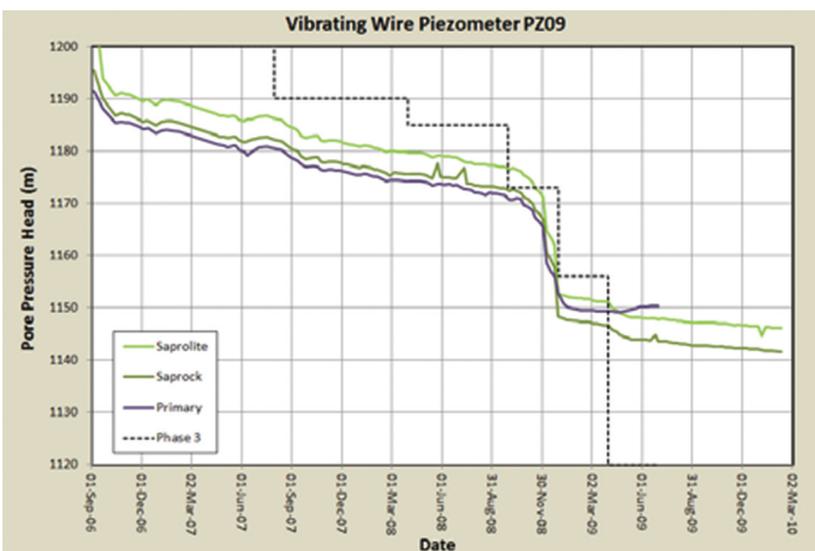
Figure 11

mining and drainage activities that were being undertaken during this period failed to identify an obvious driver for the observed depressurization in the two piezometers. However, by a process of elimination, the initial pore pressure increase is now believed to have been the direct result of the poor performance of the depressurization/dewatering systems, followed by the onset of slope failure, a corresponding dilatation of the rock mass (primary and secondary), and a temporary

Piezometer PZ9 pore pressure head.

enhancement to drainage - hence the apparent depressurization. There is a useful analogue within these responses – using ongoing pressure monitoring and trends to anticipate problems ahead of time, and allow corrective actions to be set in place.

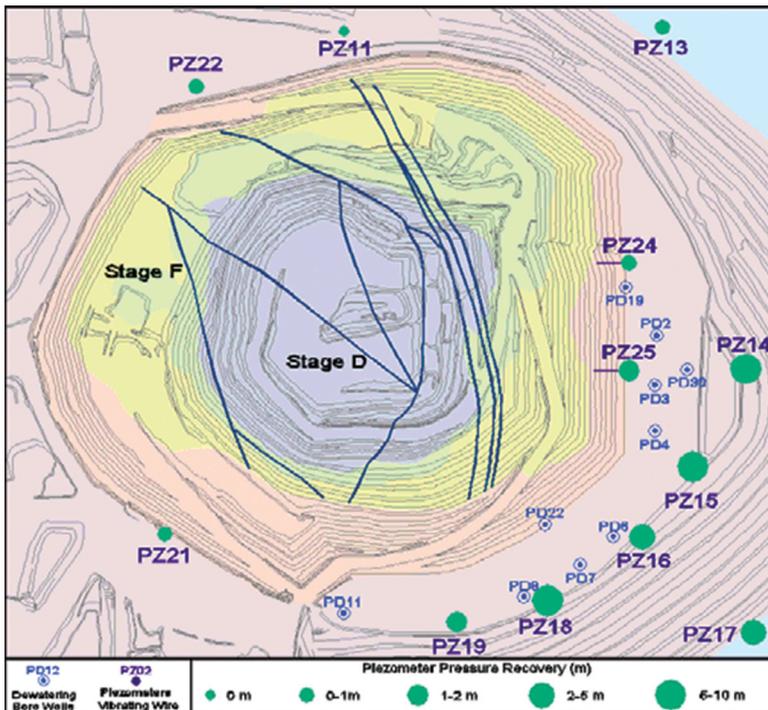
Figure 14

Piezometer pressure rebound (June 2010) during recovery test.

During the one month duration of the recovery test, a widespread response was registered in the vibrating wire piezometers around the pit perimeter. Maximum recoveries were on the order of 10 m (equivalent pressure head increase) and occurred within the saprock and upper primary rock materials, i.e., the main draw zone targeted by the dewatering bores. The distribution of the observed recoveries, in proportional symbol format, is presented in Fig. 14.

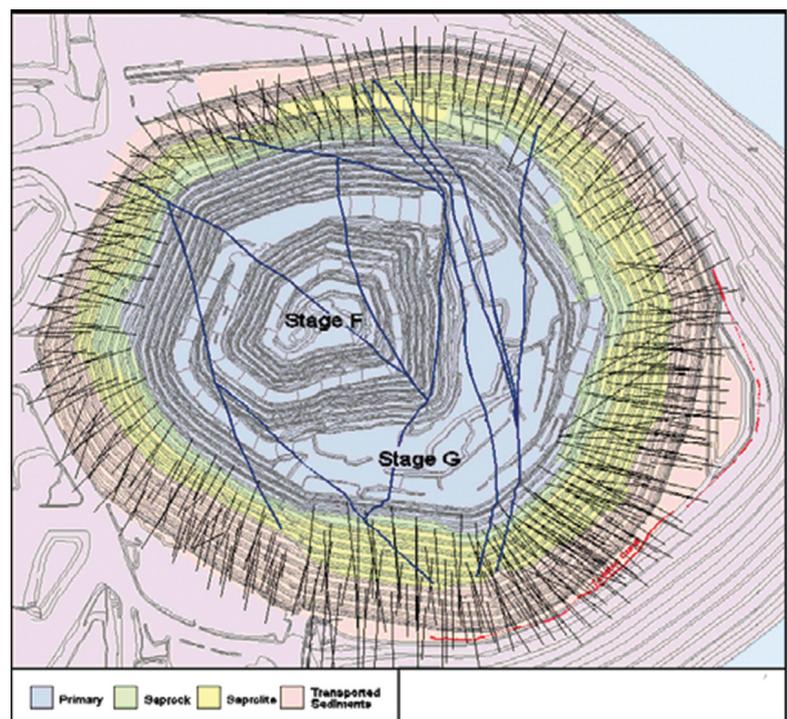
Figure 21
Pit with all horizontal drains – December 2013.

Almost 21,000 m of horizontal drain holes were drilled in 2013. A map with all of the horizontal drains in the pit wall, regardless of the year they had been drilled, is presented in the Fig. 21. It is truly an impressive figure.

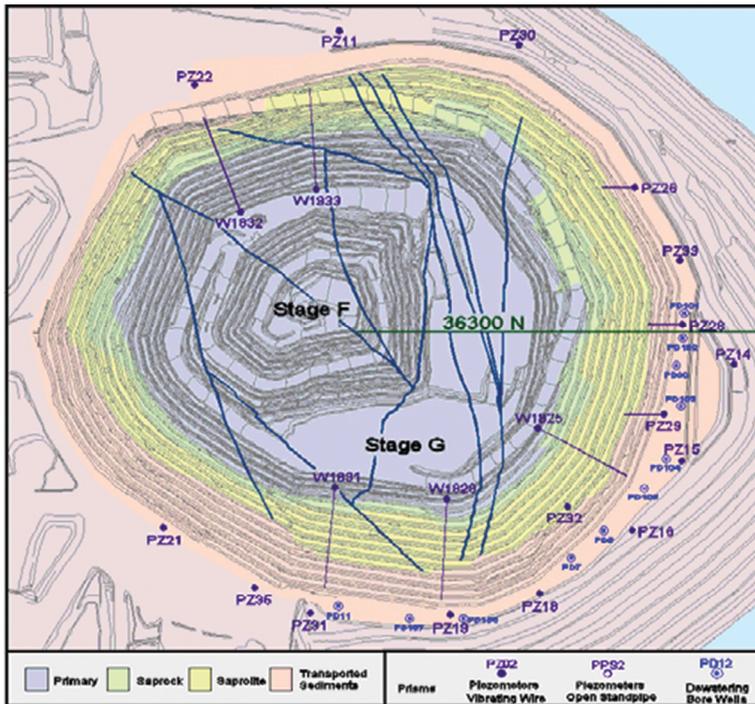
Figure 22

Pit with piezometers and wells – February 2014.

In February 2014, piezometers were installed in five horizontal drain holes located below the base of the saprock, as shown in Fig. 22. The purpose of the new piezometers was to allow better calibration of the ground water pore pressure model, which was to be used in a three-dimensional numerical slope stability model in mid-2014.

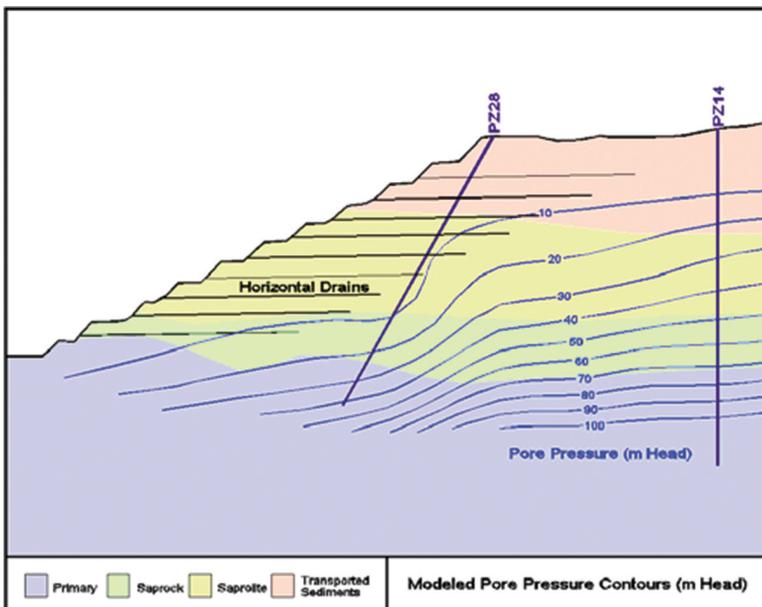
Figure 23

Cross section 36300N with pore pressure head contours – February.

The updated piezometer information enabled further refinement in the details of the ground water pore pressure model in the transported sediments and saprolites. The modeled pore pressure distribution for cross section 36300N, the same cross section shown previously, is shown in Fig. 23

Pore pressure magnitudes (equivalent metres pressure head) are presented in Fig. 23 along with the horizontal drains that were active at the modelled time step. The available pressure control used to construct the model has delineated a continued response to the drain installations, along with a sustained depressurisation within the underdrained zone.

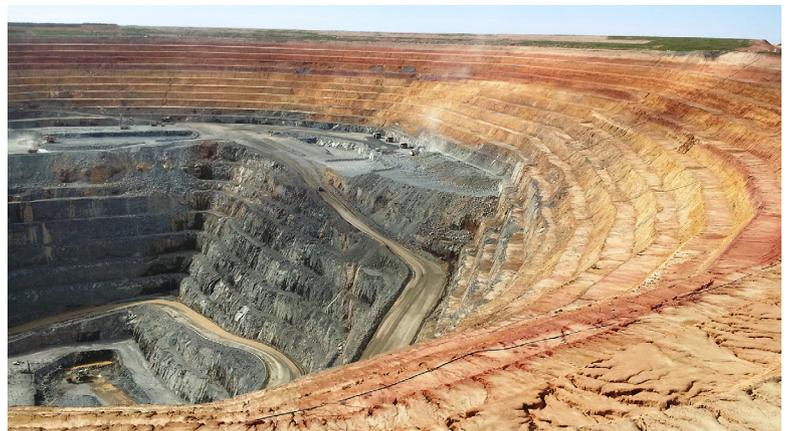
Figure 25

By September 2013, the Stage G excavation through the transported sediments and saprolites was complete, as shown in Fig. 25.

Stage G successful excavation through saprolites - September 2013.
