Gibson Mine:

A historic restoration by the Friars

by Pejman Eshraghi and Michael C. Ford

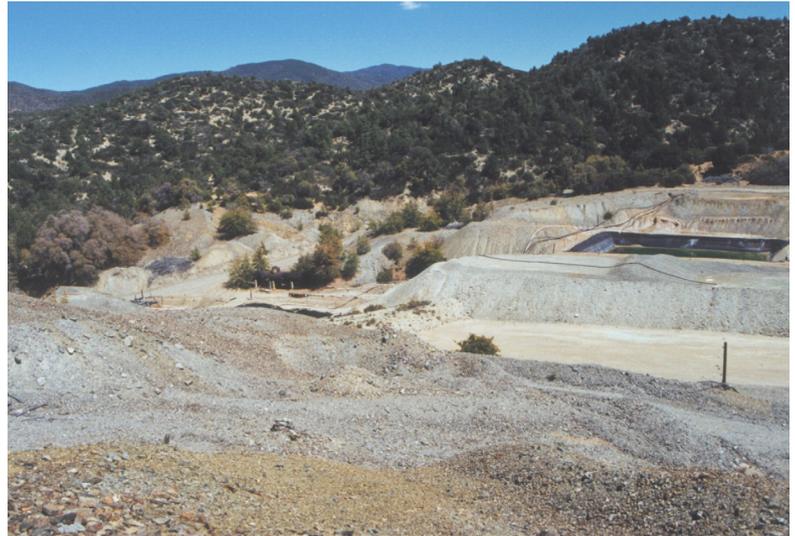
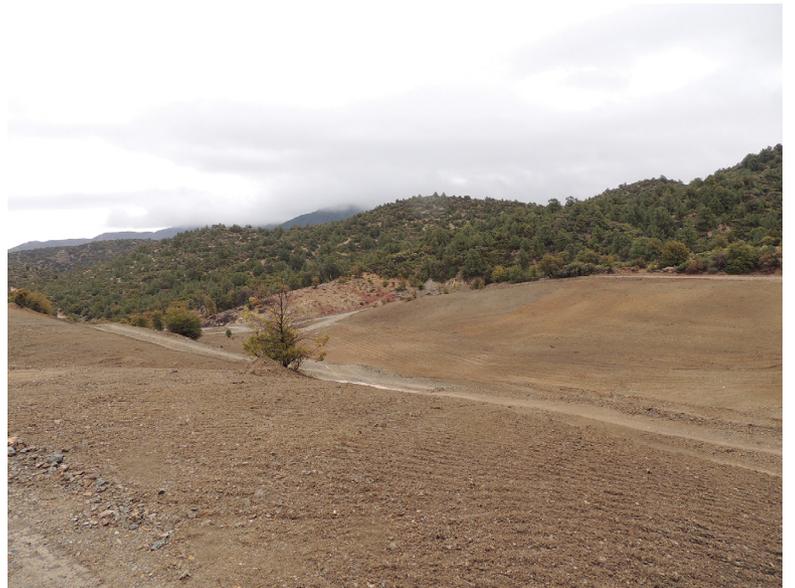
Before (above) and after photos of the heap leach facility at the Gibson Mine.

The first phase of reclamation began in 2006, with more than 91 kt (100,000 st) of heap leach materials and old vat leach tailings excavated and transported to Pinto Valley for copper recovery, saving an estimated \$3 million when compared to conventional transport and disposal at a landfill. Liners were removed from the four process solution ponds and impacted soils beneath two of the ponds were excavated down to bedrock and recontoured, while clean soils beneath and surrounding the other ponds were re-contoured. A second ADEQ grant provided for the design and installation of an anaerobic permeable reactive drain to mitigate the acid rock drainage on the Mineral Creek side and promote biological reduction of sulfate to sulfides.

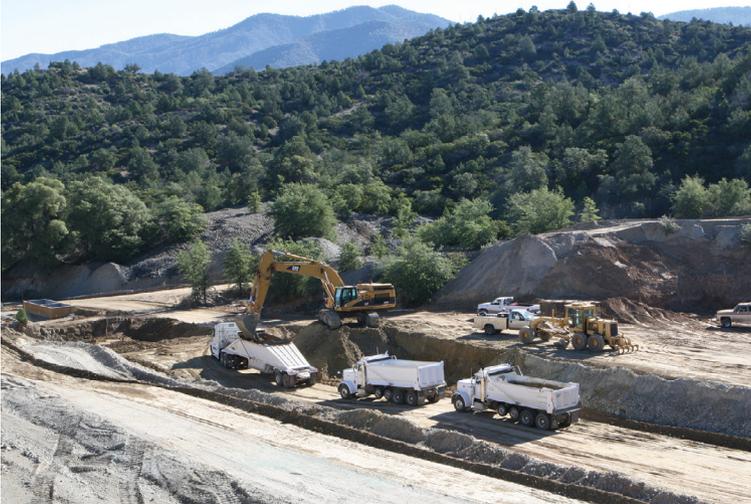
Excavation operations at the heap leach pad at the historic Gibson Mine.

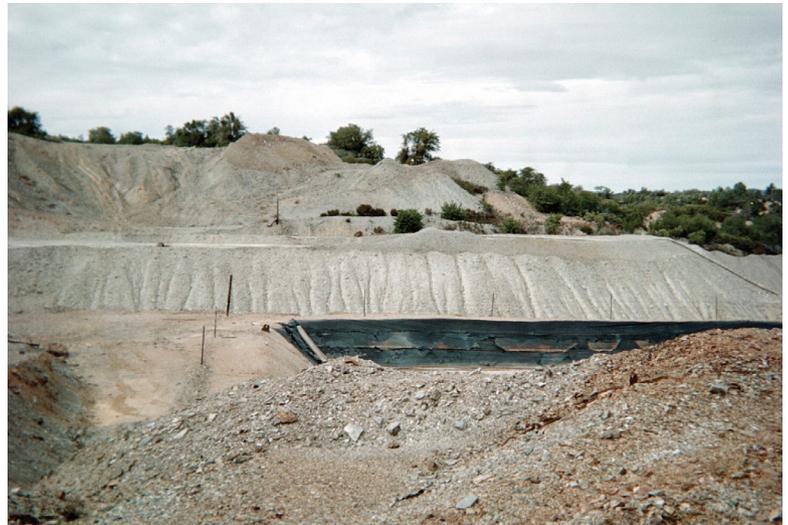
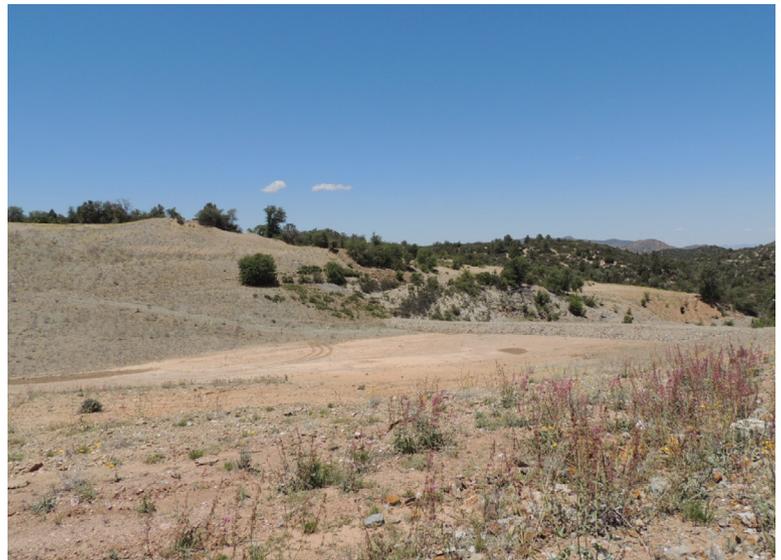
Before (above) and after photos of the reclaimed raffinate pond, heap leach pad and waste rock tailings at the Gibson Mine.

The site was divided into disturbed and undisturbed areas. Clean storm water generated on undisturbed land was diverted to bypass the mined areas and discharged downstream. Storm water generated on previously disturbed lands, encompassing all previous mine operations, was channeled to newly constructed impoundments to retain the impacted water on site. Previously disturbed areas were then covered with more than 23,000 m³ (30,000 cu yds) of clean soil and a vegetative cover was established.
